CheXpress[®] CX30

Remote Capture Check Scanner

Service Manual

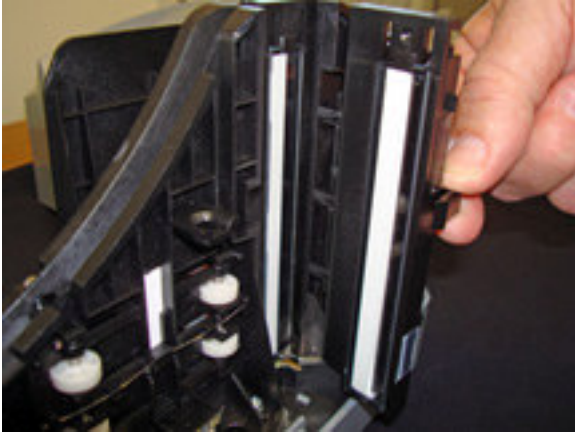
(Fig. 7)

CIS modules – The door swings open 90 degrees for easy access and cleaning.

The CheXpress™ CX30 Scanner utilizes the latest Contact Image Sensor (CIS) technology to acquire the raw check images. CIS modules are completely self contained assemblies comprising the three LED light sources (RED, GREEN, BLUE), optical rod lens, signal amplifier, and photo-diode receptors mounted to a ceramic substrate. These components are housed in a molded plastic module and operate from a single voltage power supply (see illustration below). The module has a hardened polished glass faceplate on the viewing side. These devices have an extra long depth of focus specification, providing for optimum focus when the document is anywhere between the vertical walls, and producing the highest quality image definition and contrast.

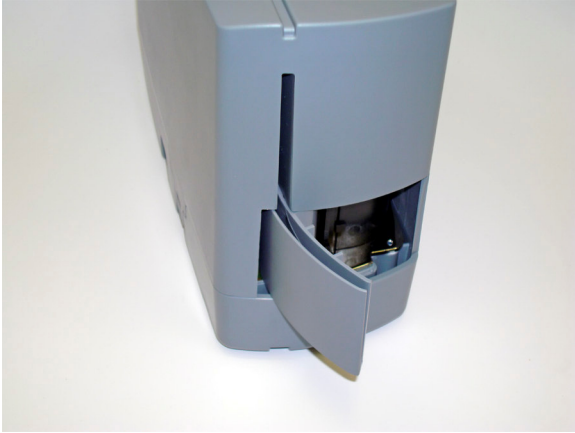
(Fig. 8)
Exit door in the open position

The normal (default) operating mode for the CX30 scanner is Scan & Return. In this mode, the document is first loaded into the entry tray, then driven forward through the scanner, then returned back to the entry tray. In this mode, the document is kept internal to the scanner at all times thereby eliminating the need to have a large area kept clear at the exit side of the scanner in order to accommodate the extension of the document as it exits the unit. For exception documents (i.e. thick documents), the CX30 has an exit door which can be opened to facilitate operation in the Pass-Thru mode. In this mode, the document does not have to bend to wrap around the internal circular guide. The exit door can be manually opened or closed, and its position is monitored by an internal sensor. Thus, the scanner operating mode is automatically selected by the software as a function of the door position. In the open position, the document can pass thru the scanner and into a small exit tray. This tray can hold from 3 to 5 documents. (Fig. 8)

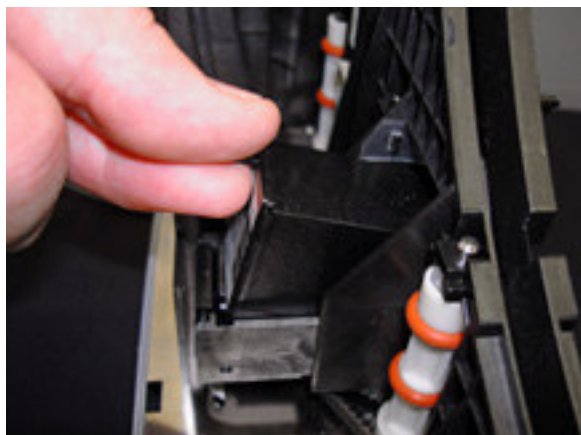
(Fig. 10)

The print endorsement on the back of the check is made using Hewlett Packard ink jet technology. The HP C6602a inkjet printer cartridge was selected because of its small size, relatively low cost, fast drying ink, and large reservoir capacity. The cartridge is available in black, red, green or blue colors, and prints up to 7,000,000 characters from a single cartridge. This cartridge has 12 nozzles and produces a good quality print with only a single pass while the check is being transported for scanning. The cartridge has an easy snap-in feature to facilitate replacement by the scanner operator (see illustration below).

Ink jet holder - Cartridge must be inserted at a slight downward angle. Then snap the back end down into place. The cartridge should be level with the base plate when properly installed.

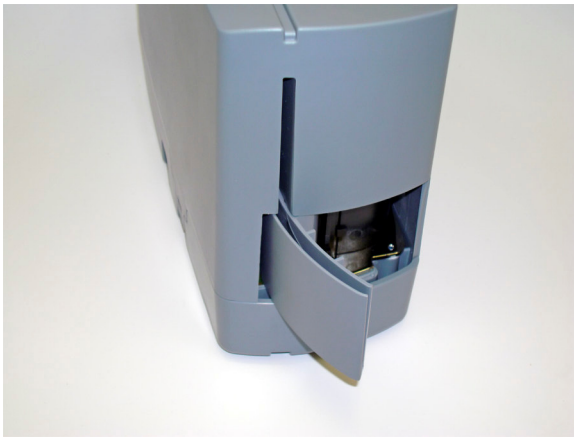
- 5.2.1 Carefully tear open the end of the foil pouch so as not to damage the card, then remove the card from the pouch.
- 5.2.2 To clean the scanner (as illustrated below), open up the exit door and launch an application (like ScanLite). Then insert the CheXpress® Cleaning Card into the hopper entrance so the leading edge is fully inserted into the entry pocket. Initiate a scan cycle and let the card get pulled in and through the scanner.
